Overall View – 6" O.D. Core x 58-1/2" Long part

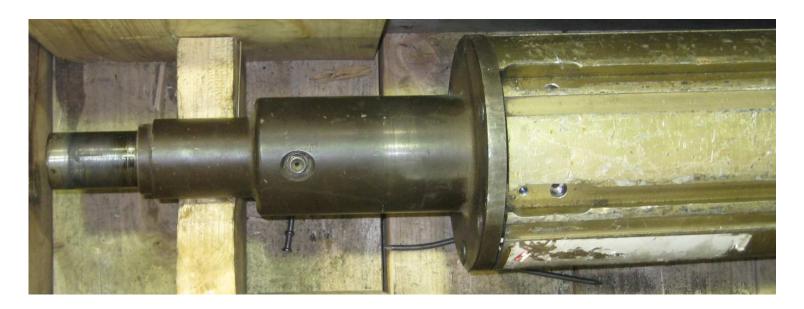
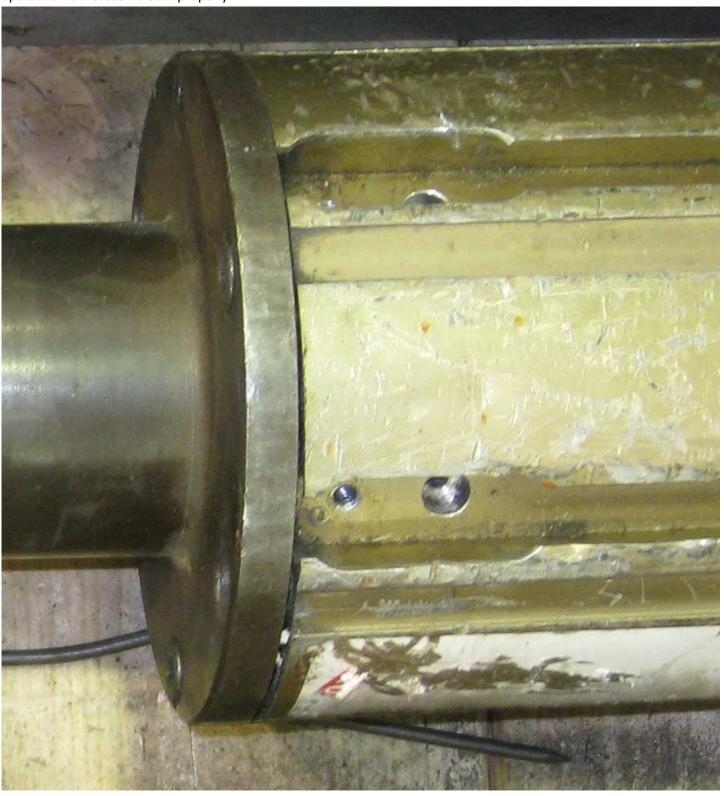
See photo above and below. Note the gap between the steel journal and the aluminum arbor. There are two cap screws missing (of the pattern of (6)). Someone has taken this

apart and not reassembled it properly.
